1. VITCEA Workshop

17th February 2015

PRODUCTION-INTRODUCED DEFECTS IN CFRP: LIMITS OF NONDESTRUCTIVE TESTING

PROF. DR.-ING.
JÜRGEN HÄBERLE

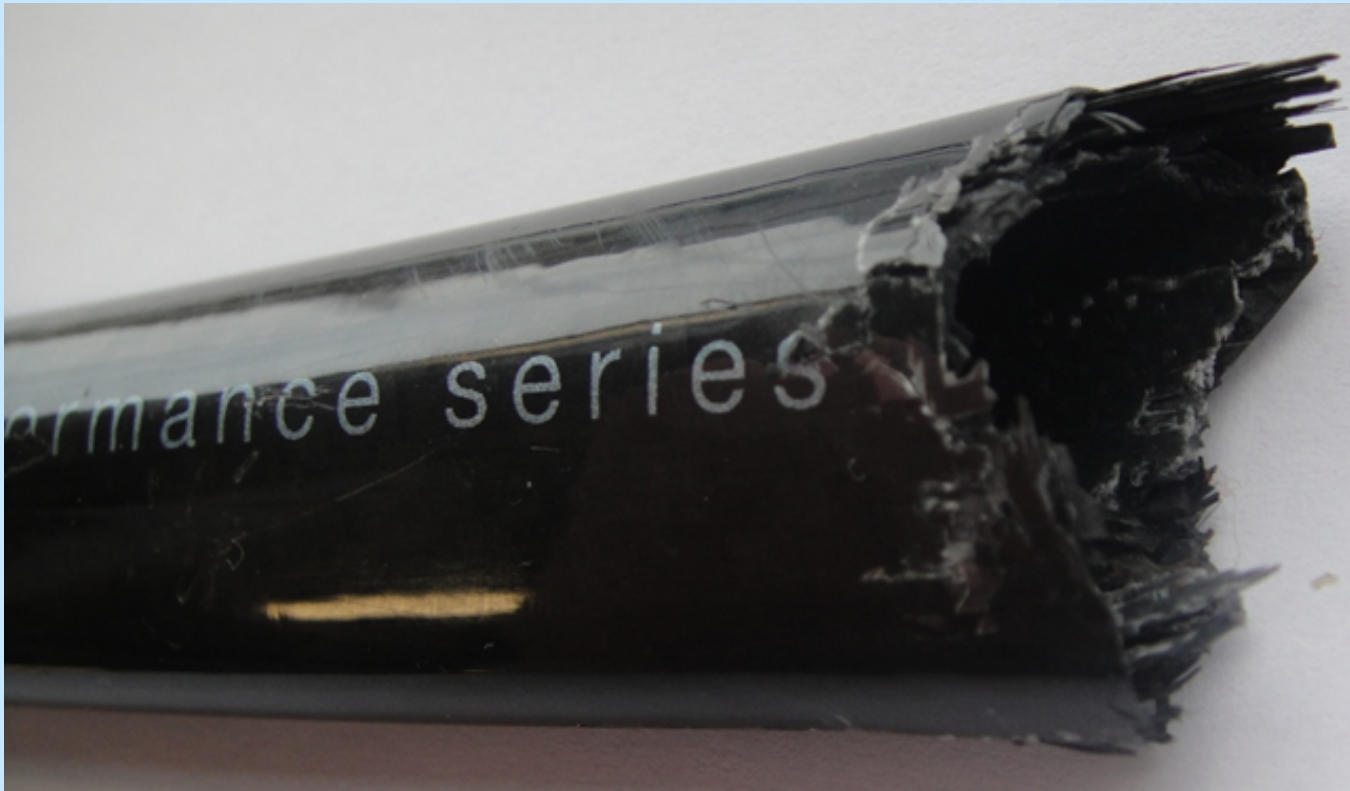
Fractured fork blade

Near-lethal accident after fracture of a CFRP fork blade of a high-end racing bicycle during „standard cycling“

Causes of failure are difficult to detect in CFRP since fracture causes secondary damages

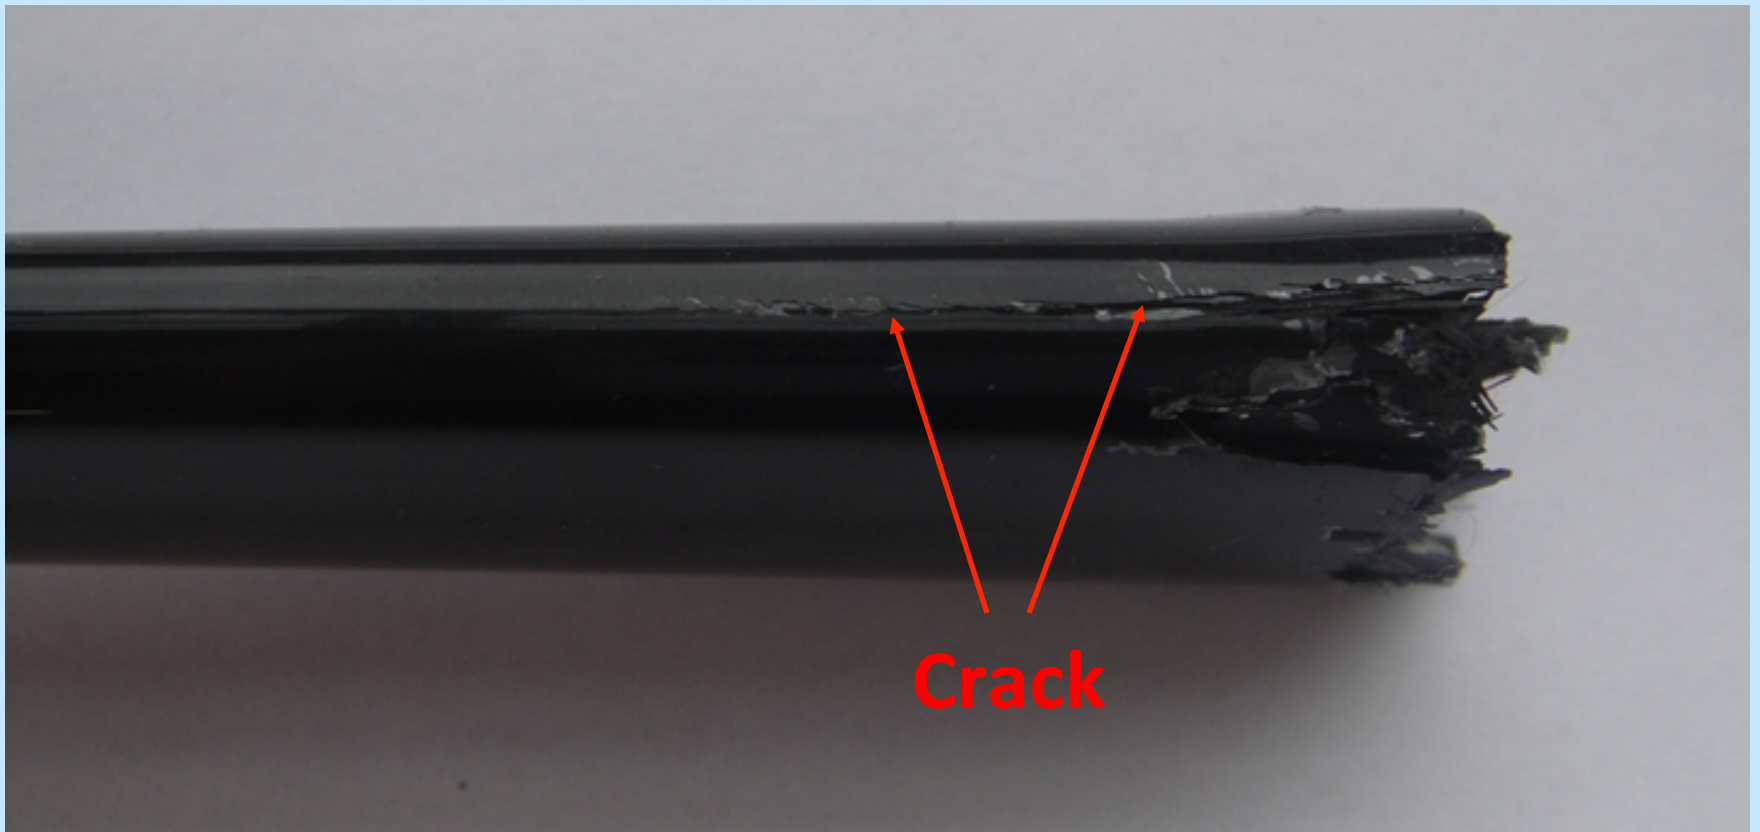
Surprising secondary damage

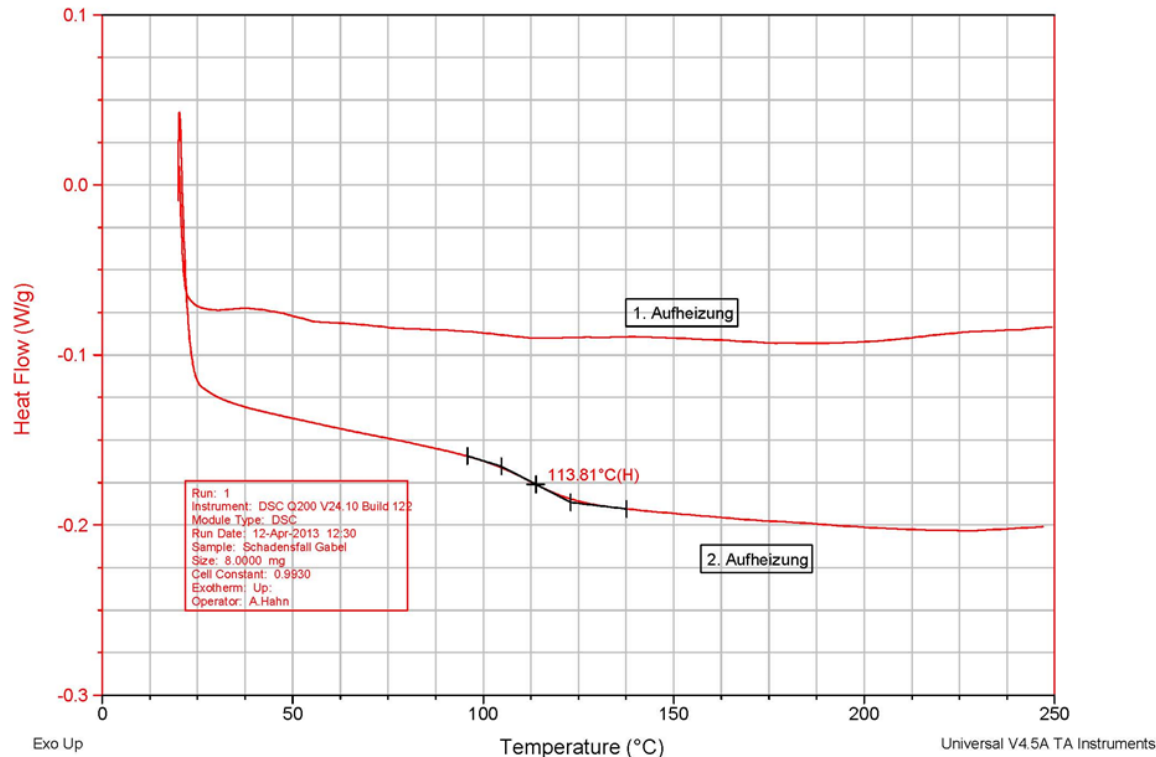
Perfect
DSC-result.

Laminate is
fully cured!

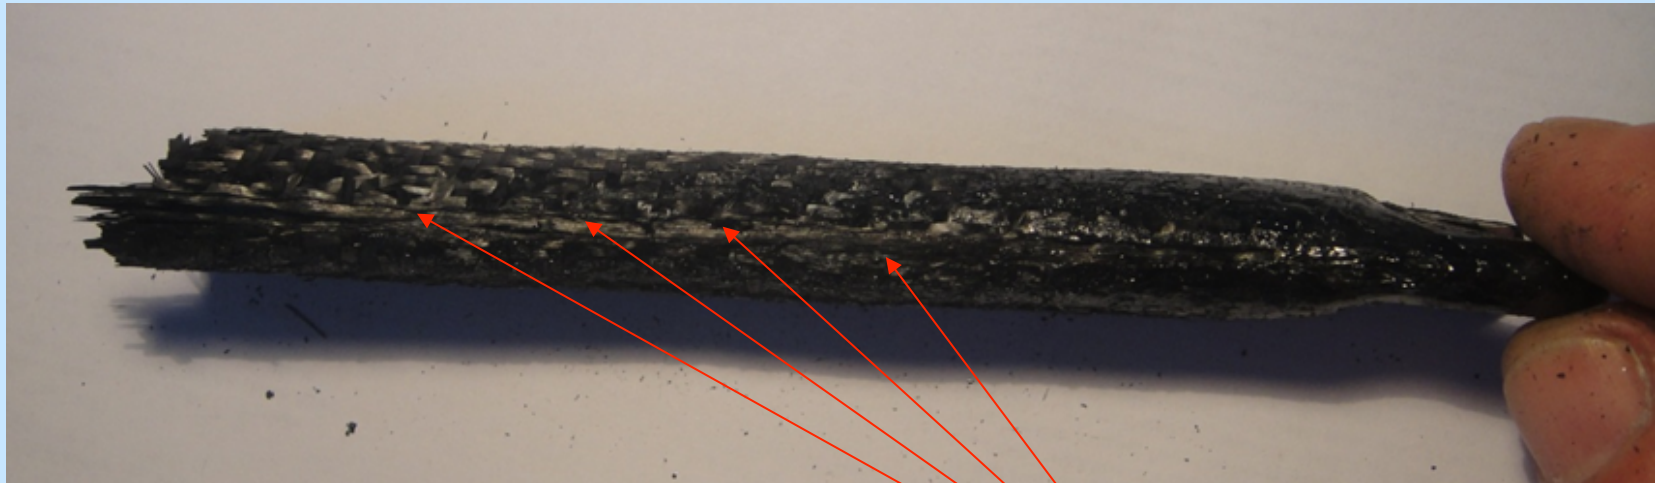
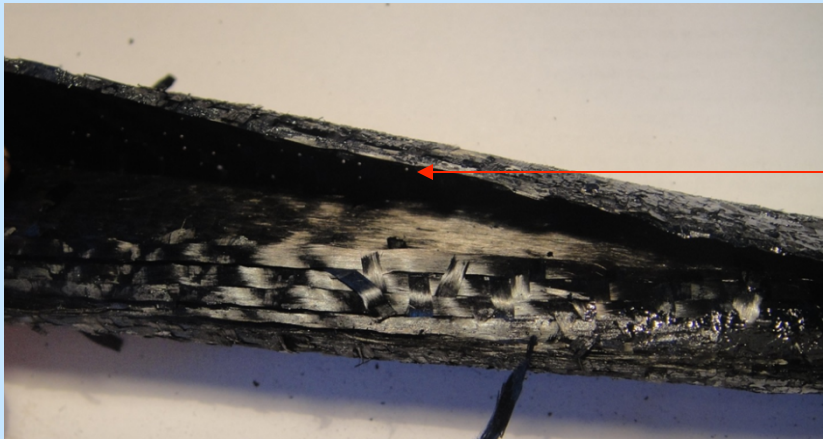
Cut fabric layer# 1

Fabric „layer“ #1 – Victim of grinding

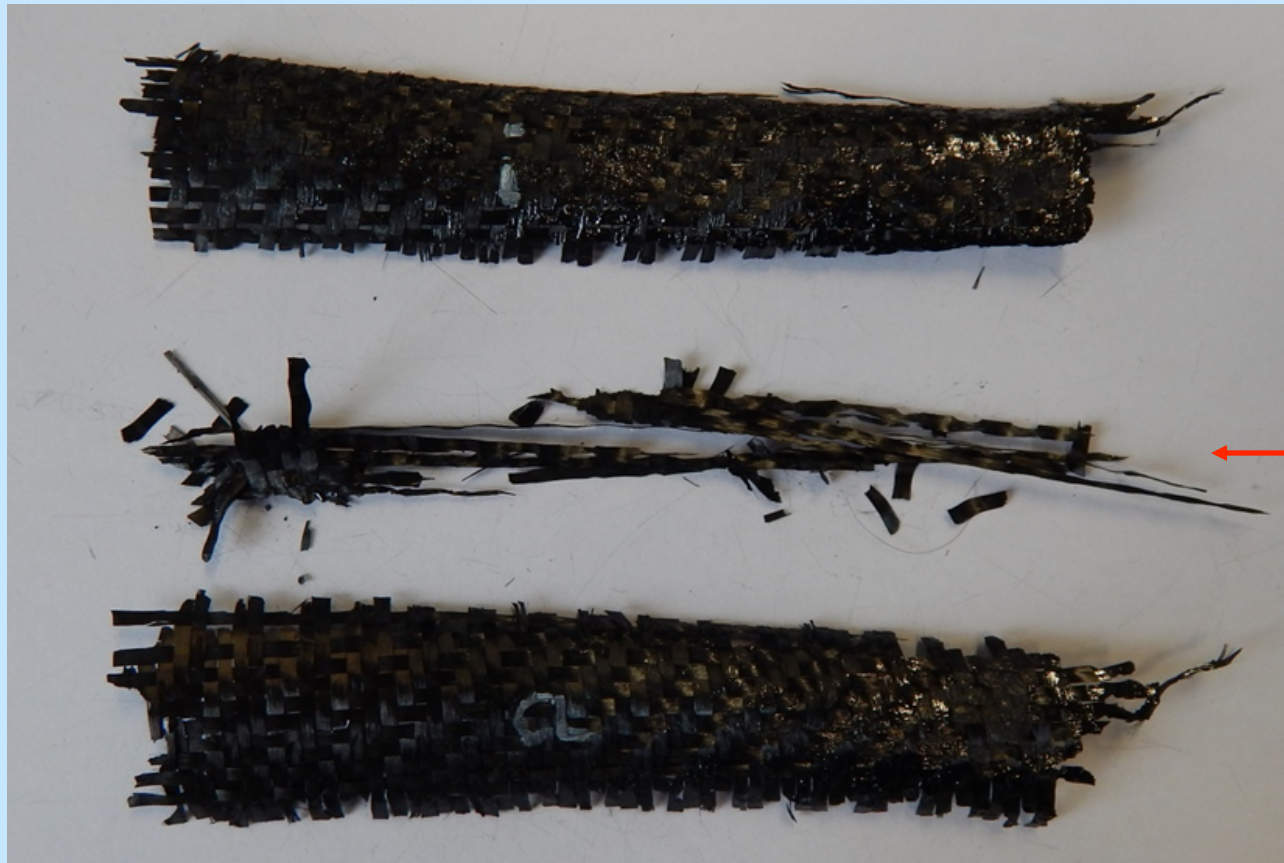
UD-layer #2

← Overlap

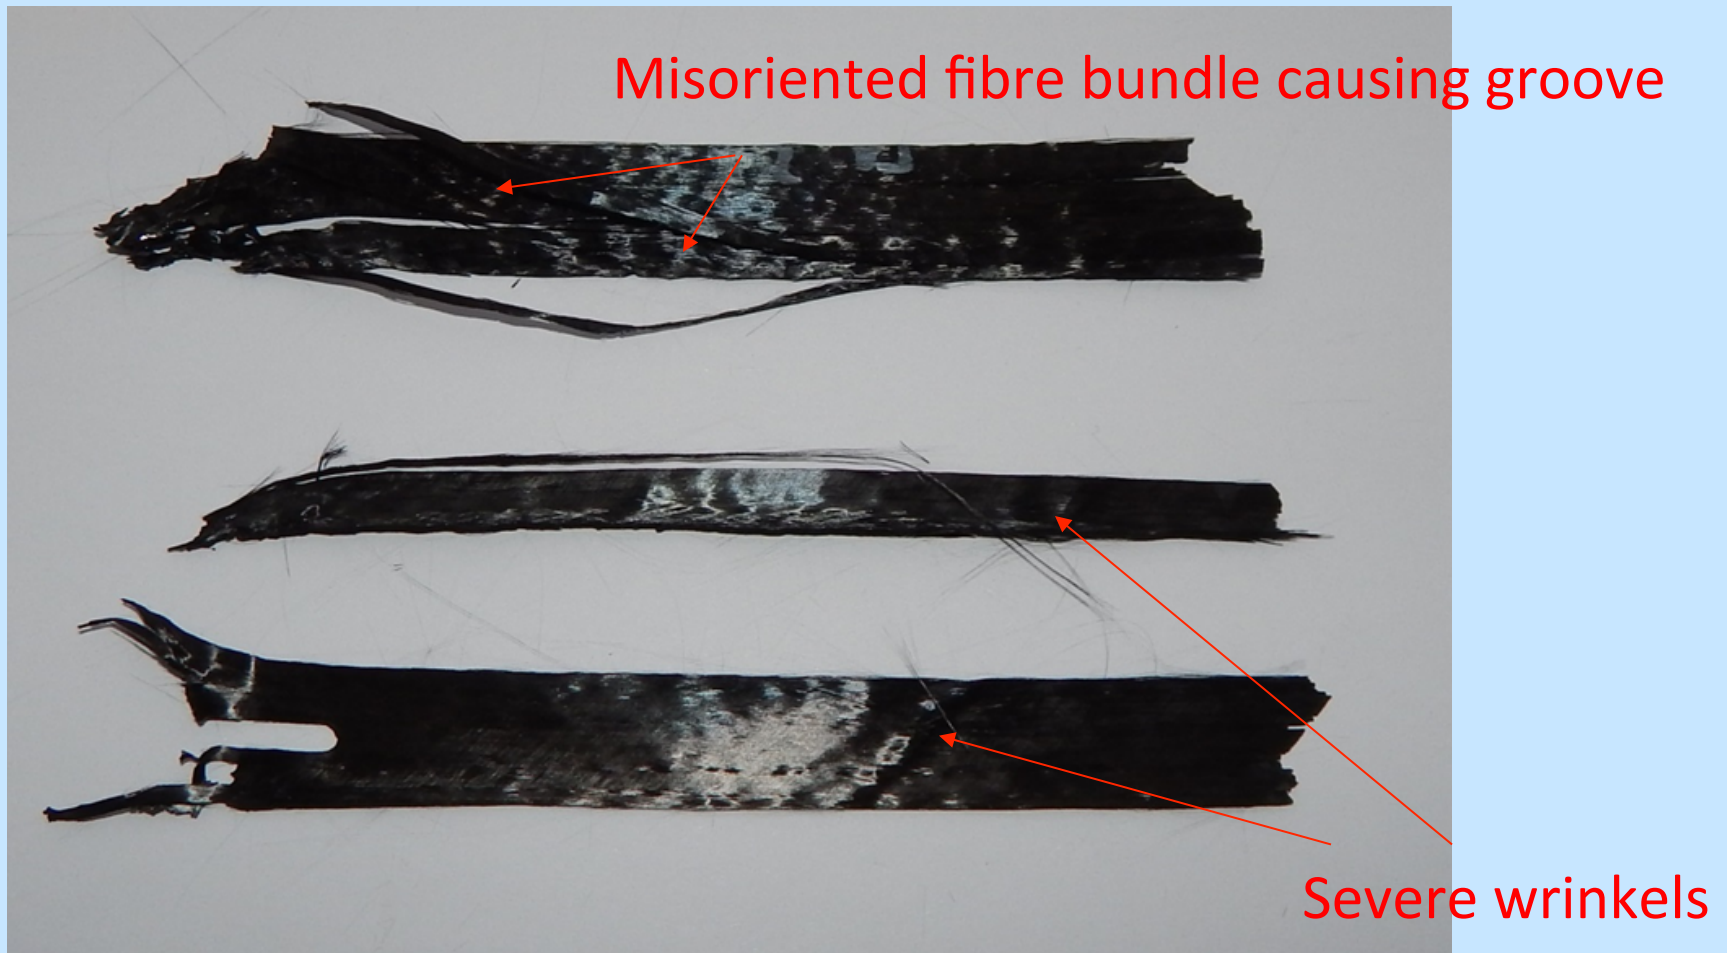
Detail of groove UD-layer #2

Imprint of fibre bundle

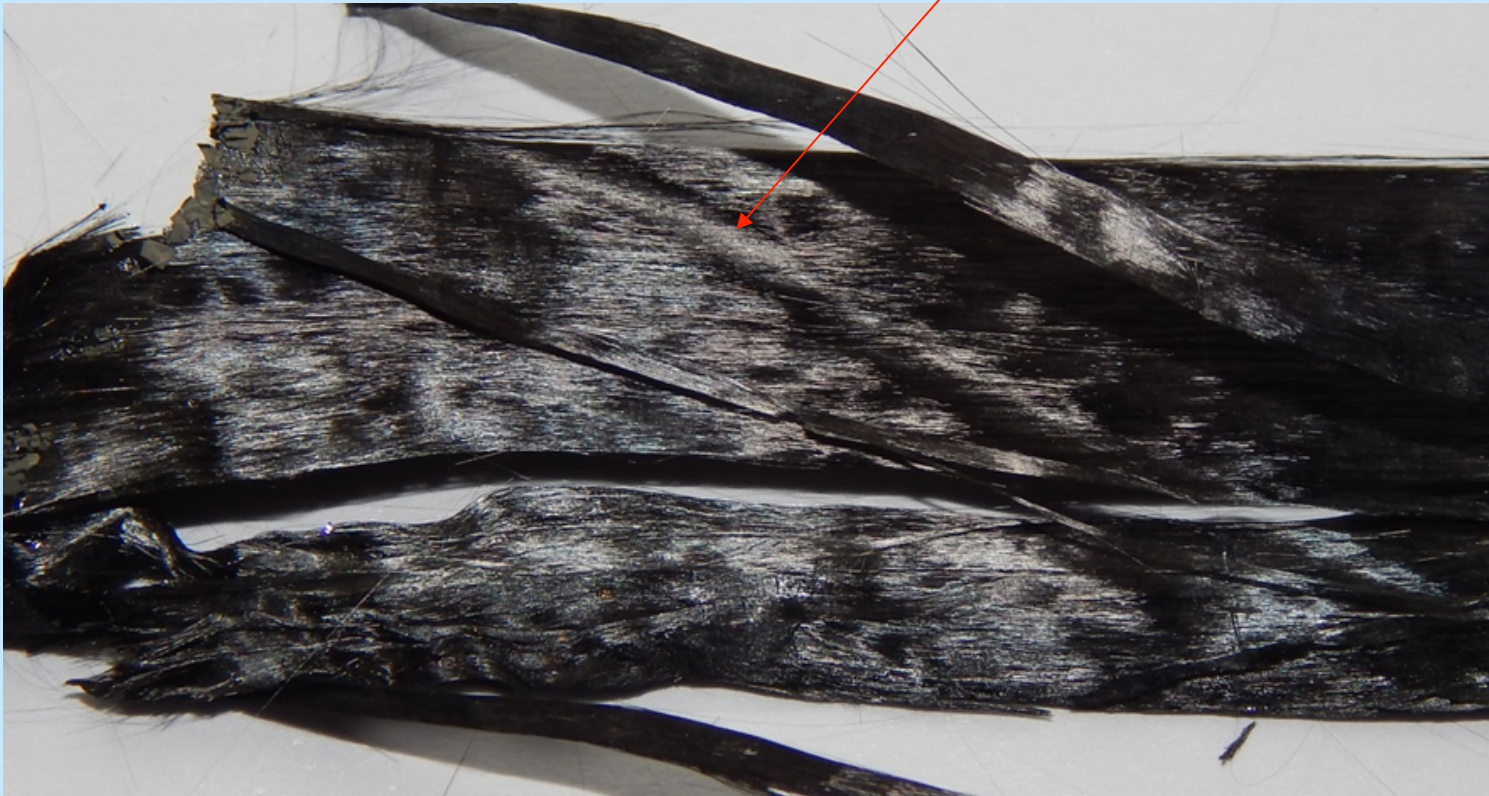
UD angled layer #3

Wrinkles

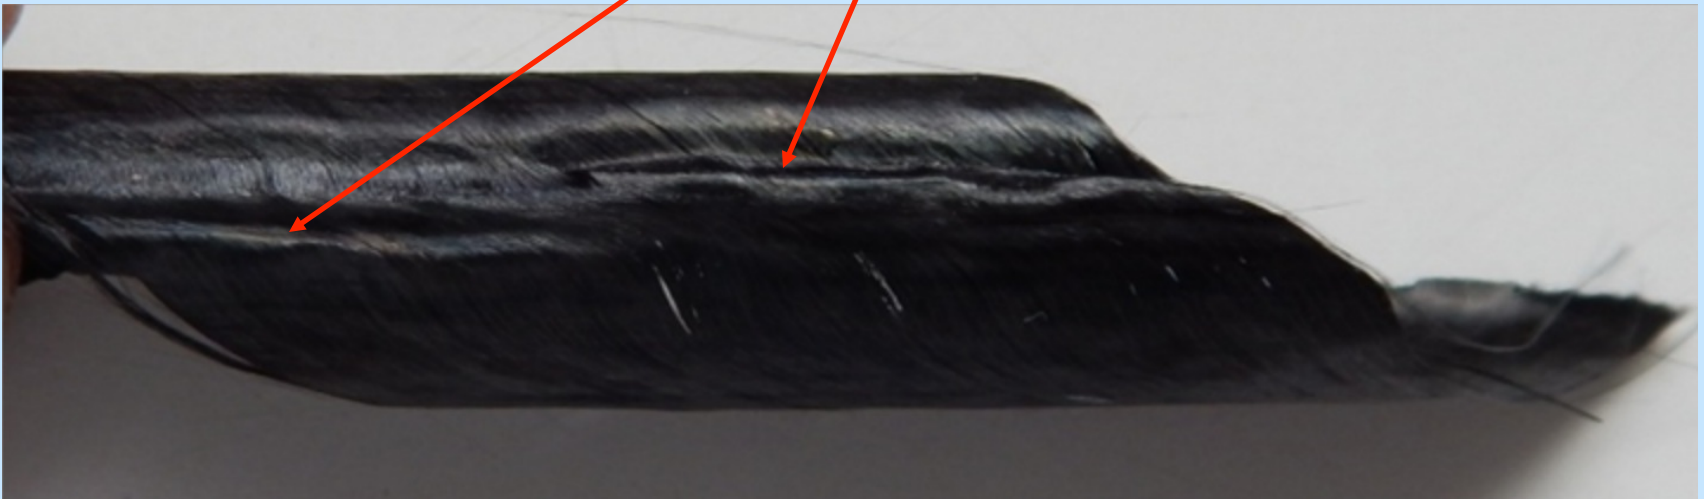
UD angled layer #4

Strong in-plane undulations and gaps

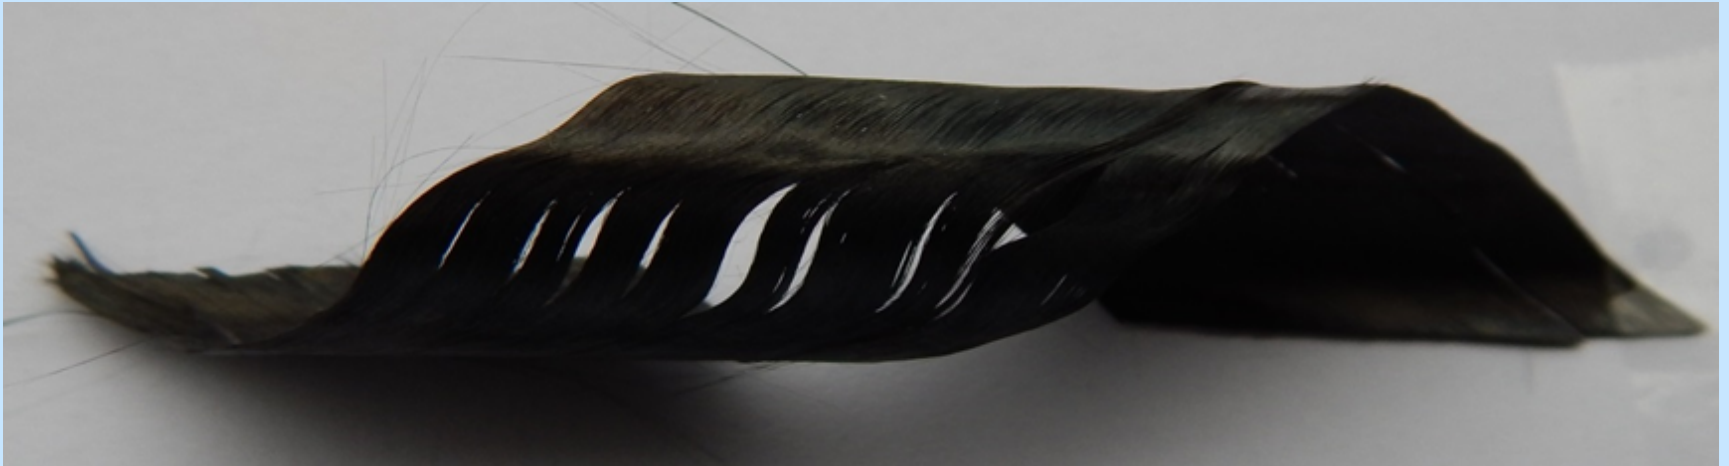
Wrinkle in thickest UD-layer #5

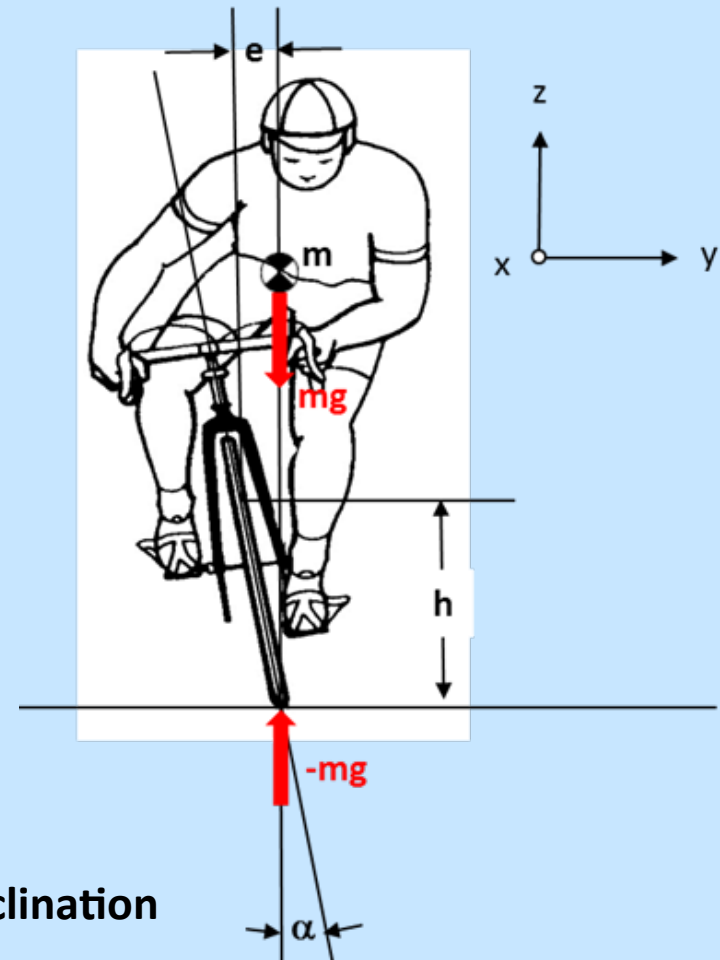
α : cyclist's declination

Maximum angle of cyclist's declination which would cause fork blade fracture:

Experimental values yield a maximum angle of **14,6°**!

Assuming a slight (reasonable) load factor of 1,5 the maximum declination angle reduces to **9,8°**!

... which is easily achieved in ambitious cycling!
