Development of a multifunctional Non-linear acoustic NDI system: Non-linear Elastic Wave Spectroscopy Imaging

ESA Contract 4000107400

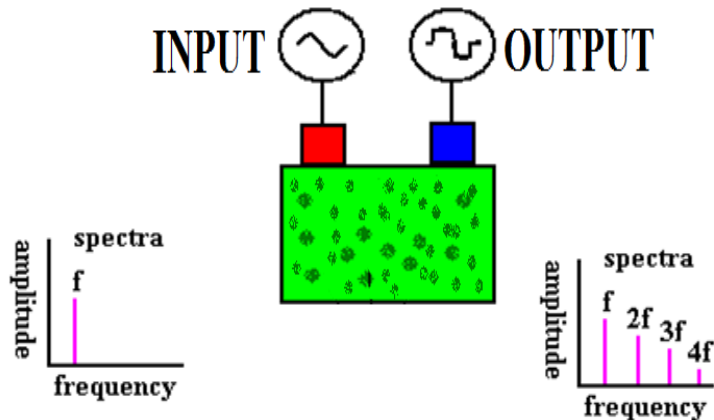
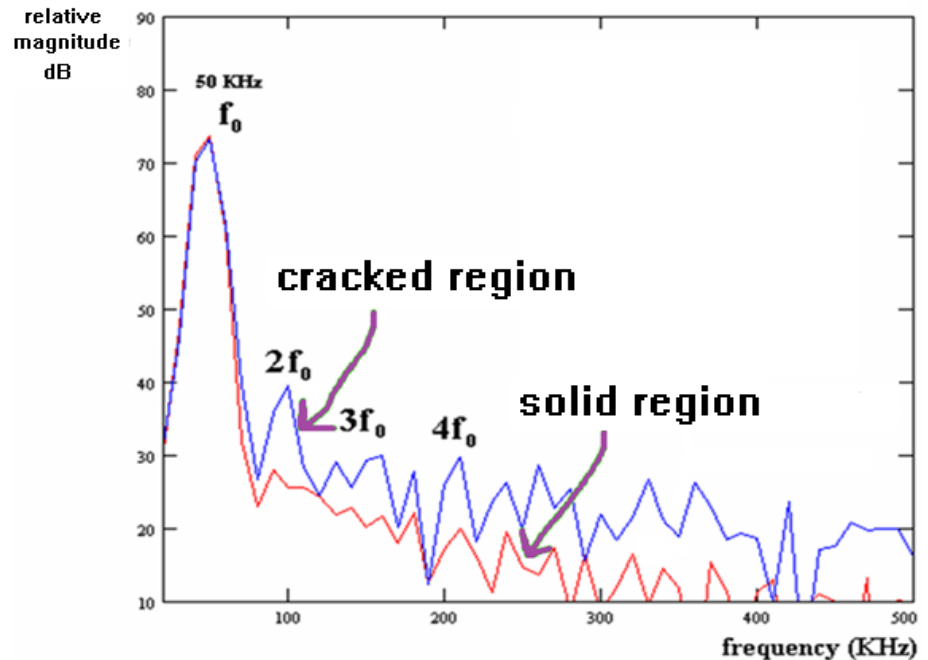
Conventional NDT can detect onset of failure at around 80% of Ultimate Compressive Strength; nonlinear acoustic detection begins around 20% UCS.

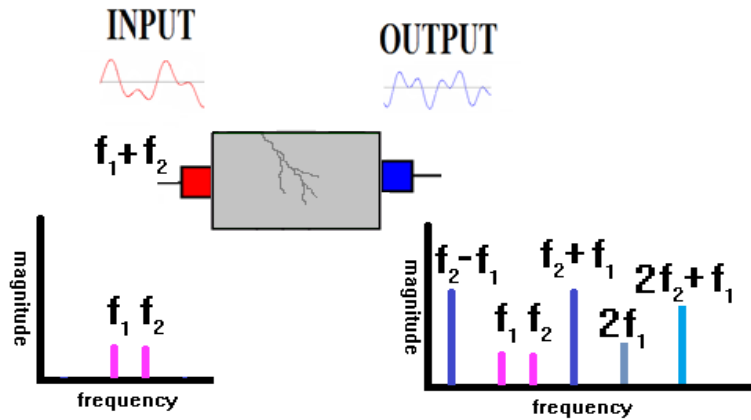
Non-linear acoustics (NEWS) techniques: 2. Dual frequency cyclic stress cracking in a steel steering actuator bracket

Generation of sidebands and intermodulation products are more sensitive indicators of damage

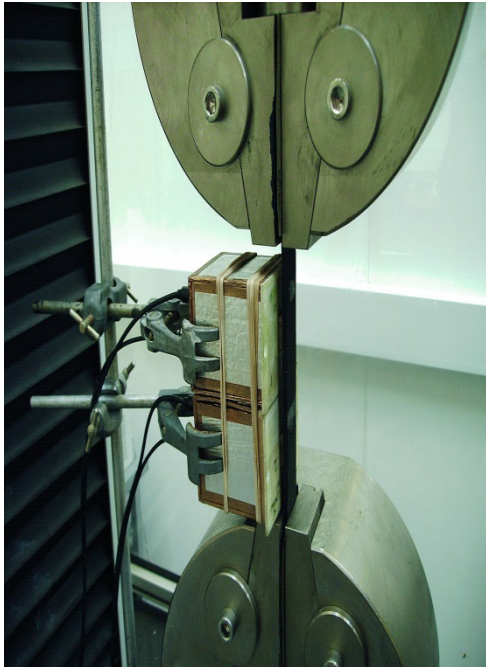
tensile loading damage in a thin strip of carbon fibre composite

Compressive and tensile pulses give equal and opposite (symmetrical) impulse responses on linear undamaged materials

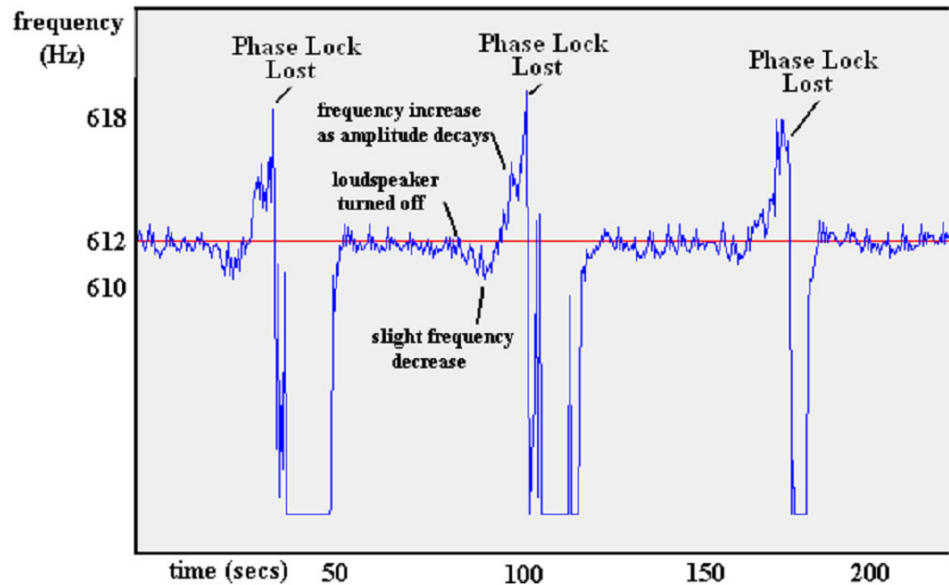
cyclic stress cracking in a steel steering actuator bracket

Object brought to resonance using a loudspeaker

Frequency very accurately measured as the amplitude decays using a phase lock loop frequency meter

Nonlinear resonance frequency variation versus amplitude

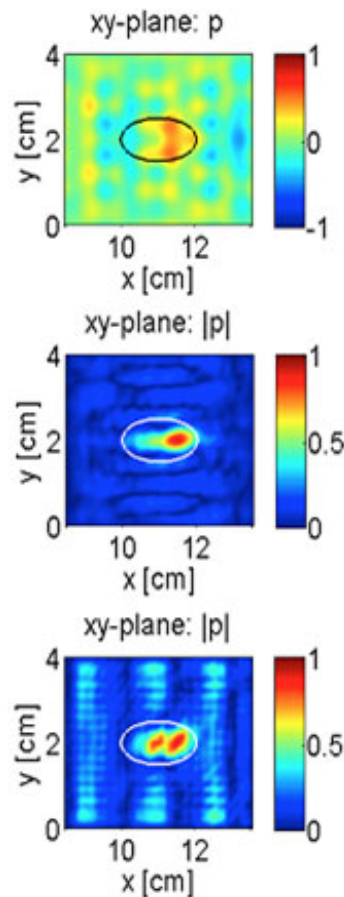
Finite Plate

Reflecting boundary
(non-infinite specimen):
Increase in noise due to reflections,
but still able to detect defect at
5-15mm above surface

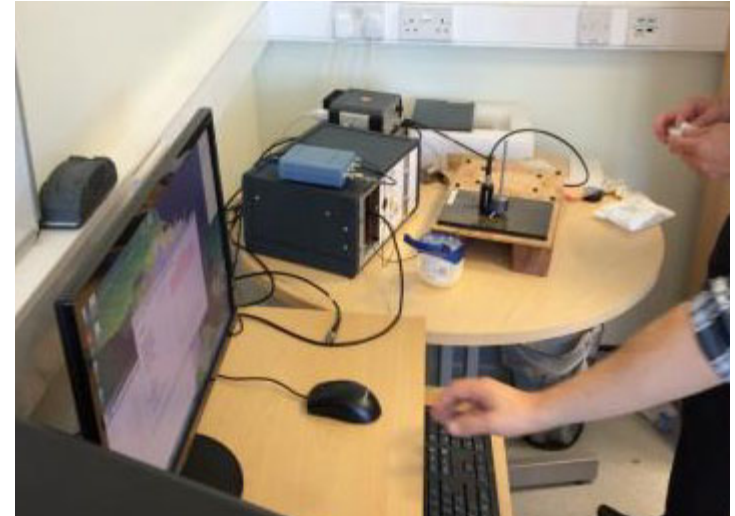
- Build system and Develop basic software function for data acquisition and analysis
- Functionally test all sub-systems
- Software for imaging has focussed on single frequency defect discrimination to understand performance of basic operation mode.
- Display colours represent ‘threshold – sigma confidence levels’ of the harmonic ‘signature’ of a control sample of the undamaged materials compared to the defective RDA sample.
- White and yellow are no-detection, orange is threshold level of detection of a defect and red is high confidence (3 sigma) detection of a defect.

3x3 scan of composite RDA with kissing de-bond

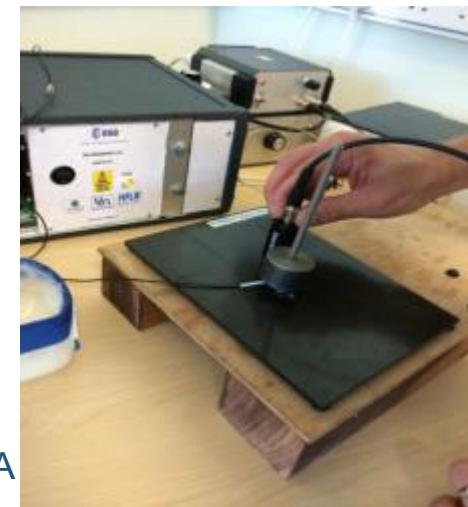
- NACE – scan of air-coupled detection of kissing de-bond RDA
- Spectrograms indicate a change in harmonic signature
- The top spectrogram shows the fundamental and lower down various harmonics with the receiver positioned over the defect (1 and 2) and a different location away from the defect (3).
- In a control sample (bottom image), the harmonic generation is noticeably weaker compared to the defect area.
- Analyser discrimination software not yet optimised for NACE

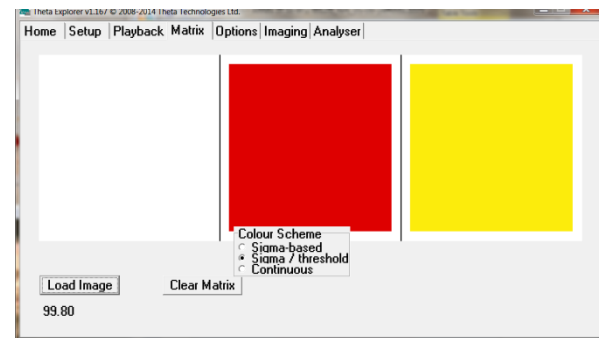
- Repeated tests on 50mm KBs
- Diagonal 3x1 scans
- Consistent central detection (white and yellow is below detection threshold.)
